# Manhole Inspection Summary

Manhole # S09II2010MH

**Location** Address: **6305 GREEN MEADOW PKWY** Cross Street: **EDENVALE RD**

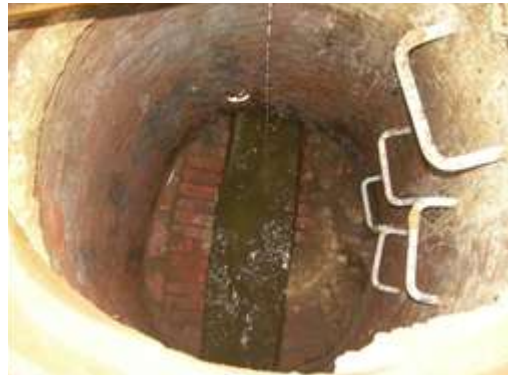
Top View

**Bench** ☒ Exists Material: **Brick** ☐ Parged ☒ **Debris** (not Condition related)  
Condition: ☒ Sound ☐ Cracked ☐ Root Intrusion ☐ Deteriorated ☐ Leaks ☐ Debris

**Surcharge** ☒ **Evidence Of Surcharge** Depth: **3** (ft.) ☐ Active Surcharge Present

Evidence of surcharge - Bench debris.

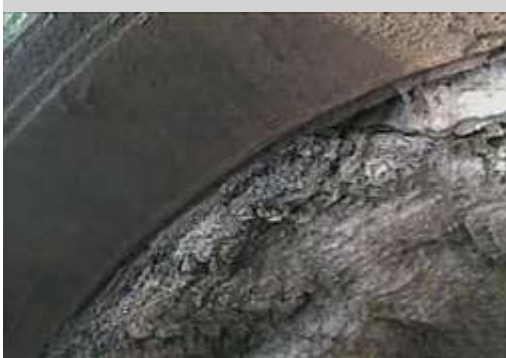
Defect

**Frame** Offset: **5** (in.) Condition: ☐ Sound ☐ Cracked ☒ **Leaks**

**Chimney / Frame Adjustment** ☒ Exists Material: **Brick** ☐ Parged Height: **5** (in.)  
Condition: ☐ Sound ☐ Cracked ☐ Root Intrusion ☐ Loose Brick ☒ **Deteriorated**  
Infiltration: ☐ None ☒ **Joint** ☐ Cracks ☒ **Mortar** ☐ Roots ☐ Wall

Frame leaks. Adjustment deterioration and infiltration.

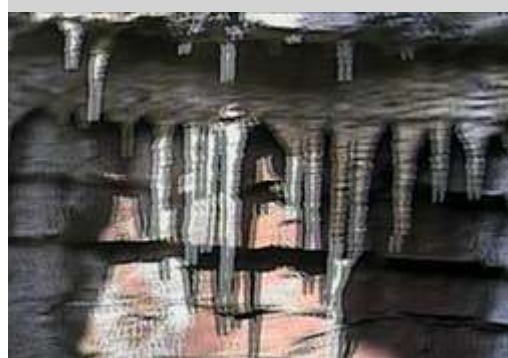
Defect

Comments **Mineral deposits present in manhole. The I5 pipe seal is not flush with pipe.**

Mineral deposits - Adjustment infiltration.

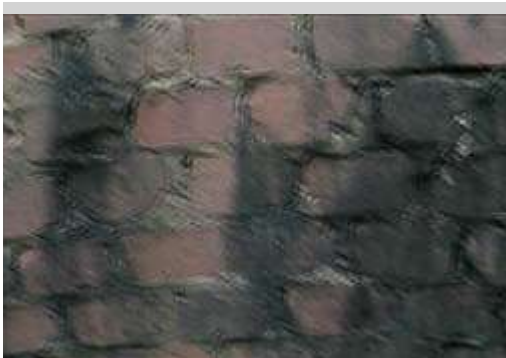
Defect

**Barrel** Material: **Brick** ☐ Parged  
Shape: **Circular** Diameter: **48** (in.) Length: (in.)  
Condition: ☐ Sound ☐ Cracked ☐ Root Intrusion ☐ Loose Brick ☒ **Deteriorated**  
Infiltration: ☐ None ☐ Joint ☐ Cracks ☒ **Mortar** ☐ Roots ☒ **Wall**

Barrel infiltration.

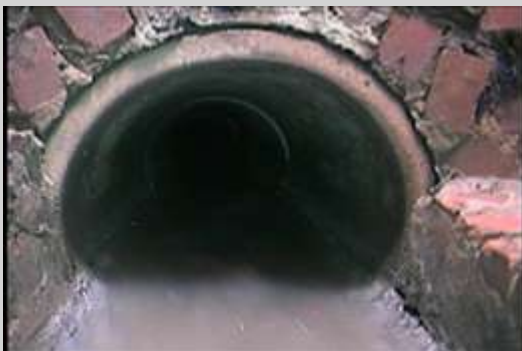
### 15 in. Circular Gravity Sewer Pipe In @ 5 O'Clock

**Channel** Material: **Brick** ☐ Parged ☐ Debris (not Condition related)  
Channel Exposure: **Fully Open** Junc Dist: **0** nearest .5 ft. Azimuth:  
Condition: ☐ Sound ☐ Cracked ☐ Root Intrusion ☒ **Deteriorated** ☐ Leaks ☐ Debris

Barrel deterioration and infiltration. Channel deterioration.

Infiltration: **Evidence** Pipe Seal Cond: **Unknown**
